Flood Control Project Maintenance
2018 Structure Summary Report
Overall Unit and Item Ratings

DWR Sutter Maintenance Yard

Butte Slough Drainage Structure

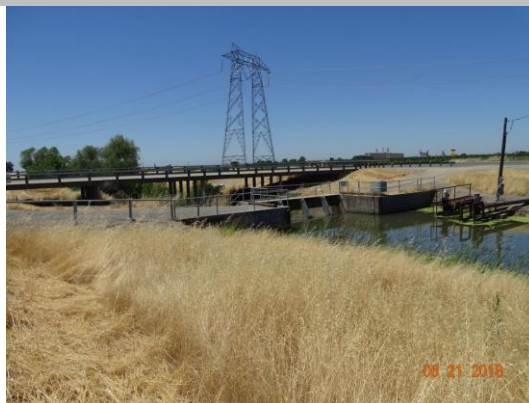
Photo 1 of 2 : ST_2018_NA0060_11_23_20180710_00004.jpg

LM Start	0.00	Rating **	N	Issue No.	23
LM End	0.00	Issue Type +	Ma	Location *	
Category	Structures & Concrete Lined Channels			GPS Latitude/Longitude	
				Start	End
Item	Photo Documentation			39.153325 °	39.153325 °
				-121.734122 °	-121.734122 °
DWR ID	DWR_NA0060_11_t_2012_23				
Action/Comments					
Inspector Comments: Upstream side of the structure is clear of debris.

View of the upstream side of the Wadsworth Canal Weir No. 4.

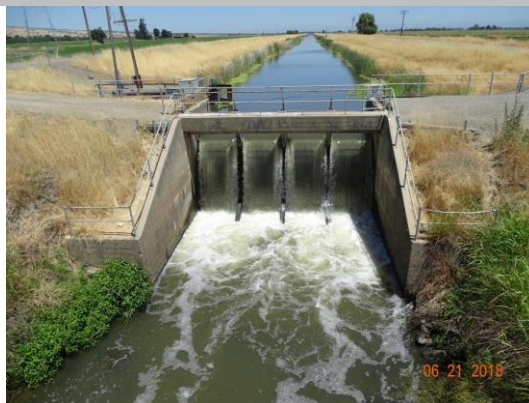
Photo 2 of 2 : ST_2018_NA0060_11_23_20180710_00005.jpg

View of the downstream side of the Wadsworth Canal Weir No. 4.

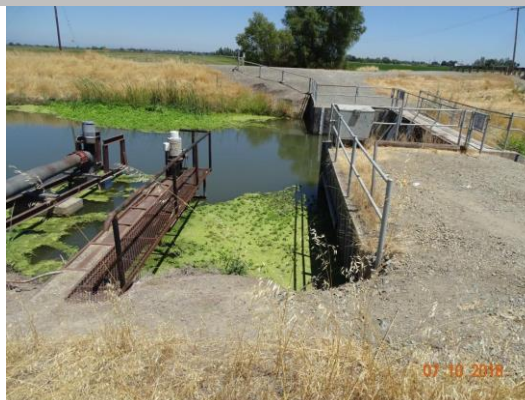
Photo 1 of 1 : ST_2018_NA0060_11_3_20180710_00006.jpg

LM Start	0.00	Rating **	M	Issue No.	3
LM End	0.00	Issue Type +	Ma	Location *	
Category	Structures & Concrete Lined Channels			GPS Latitude/Longitude	
				Start	End
Item	Erosion / Bank Caving			39.153325 °	39.153325 °
				-121.734122 °	-121.734122 °
DWR ID	DWR_NA0060_11_t_2012_3				
Action/Comments					
Inspector Comments: Repair all erosion along the channel before winter.

View of the erosion around the upstream end of the structure.
